**Flood Control Project Maintenance
Levee Inspections**

Fall 2012 Levee Maintenance Deficiency Summary Report

San Joaquin River Basin

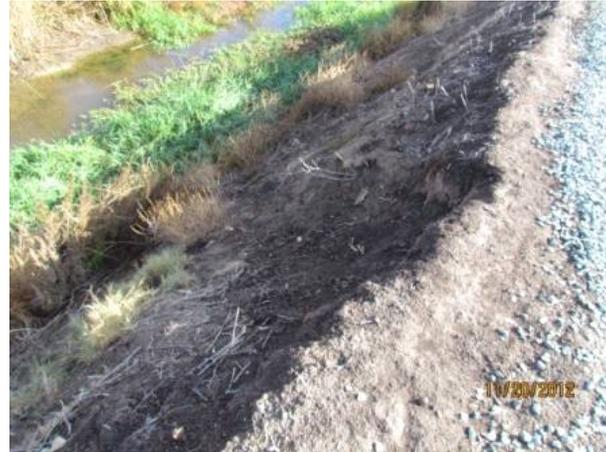
pkazi_f_20121126_148.jpg

Slope instability was found on the waterside slope of the levee looking upstream.

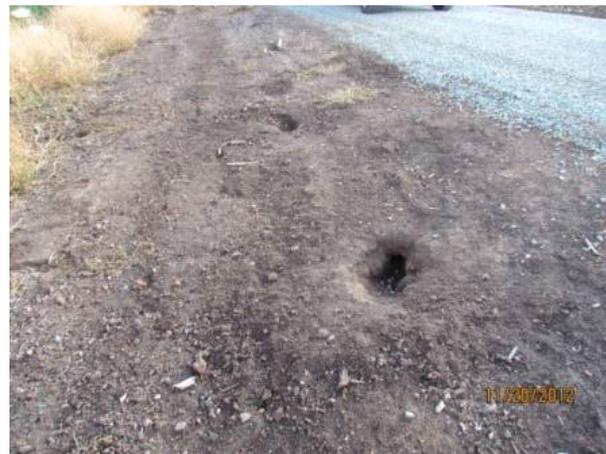
pkazi_f_20121126_150.jpg

Animal holes were found on the waterside of the levee looking upstream.

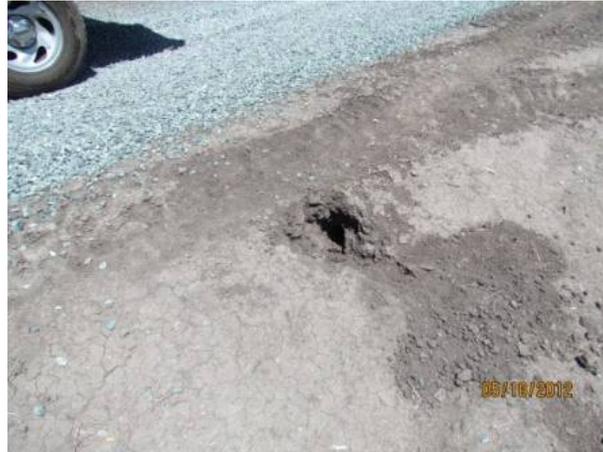
Levee Mile Report Line	4
Start Levee Mile	0.31
End Levee Mile	0.31
Location	Land Side
Category	Earthen Levee
Item	Animal Control
An animal hole was found on the landside of the levee looking downstream.	
pkazi_f_20120913_001.jpg

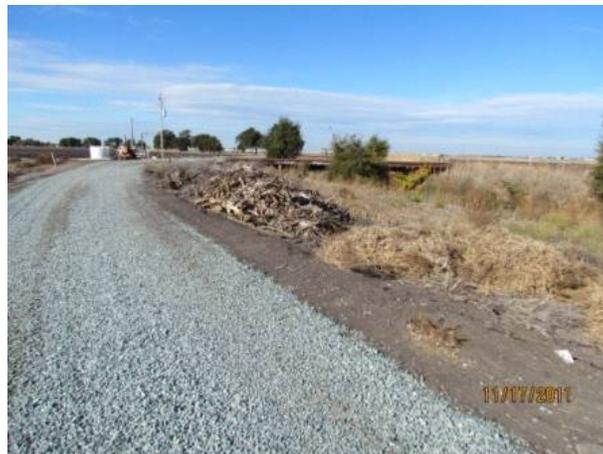
Levee Mile Report Line	6
Start Levee Mile	0.42
End Levee Mile	0.42
Location	Water Side
Category	Earthen Levee
Item	Encroachments
Prunings were found on the waterside of the levee looking downstream.	
pkazi_f_20120913_005.jpg

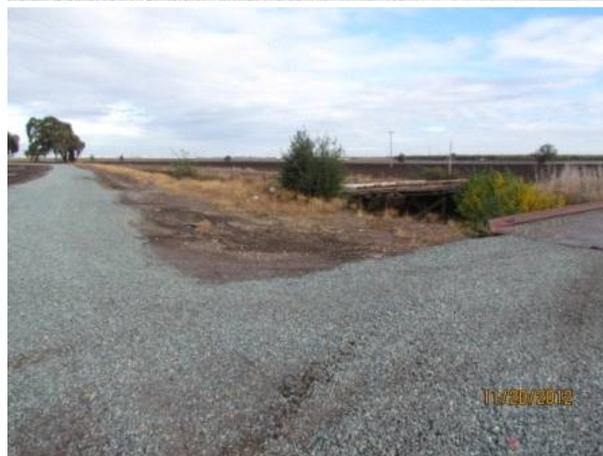
Levee Mile Report Line	7
Start Levee Mile	0.43
End Levee Mile	0.43
Location	Water Side
Category	Earthen Levee
Item	Encroachments
Debris was removed by the farmer at the landside shoulder of the levee looking upstream.	
pkazi_f_20121126_151.jpg

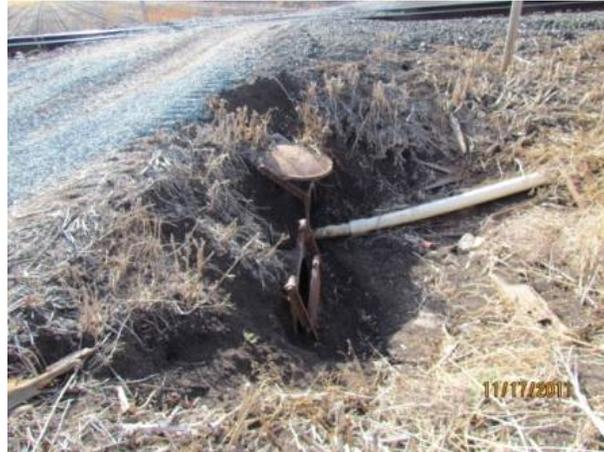
pkazi_f_20120913_011.jpg

Flap gate appeared to be broken on the waterside of the levee looking downstream.

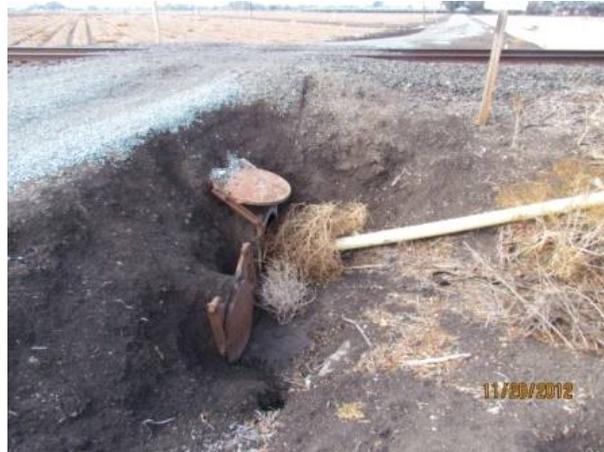
pkazi_f_20121126_152.jpg

Levee Mile Report Line	8
Start Levee Mile	1.06
End Levee Mile	1.06
Location	Water Side
Category	Interior Drainage & Piping Systems
Item	Flap Gates

Updated picture of the flap gate with pipe encroachment on the waterside of the levee looking downstream.

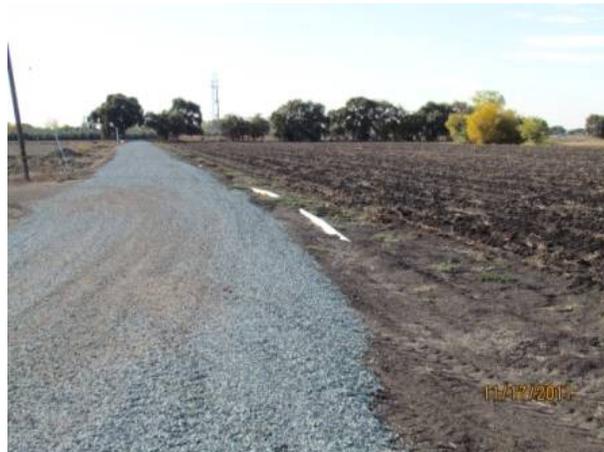
pkazi_f_20120913_007.jpg

Levee Mile Report Line	9
Start Levee Mile	1.07
End Levee Mile	1.27
Location	Water Side
Category	Earthen Levee
Item	Encroachments

PVC Pipe was found on the waterside of the levee looking downstream.

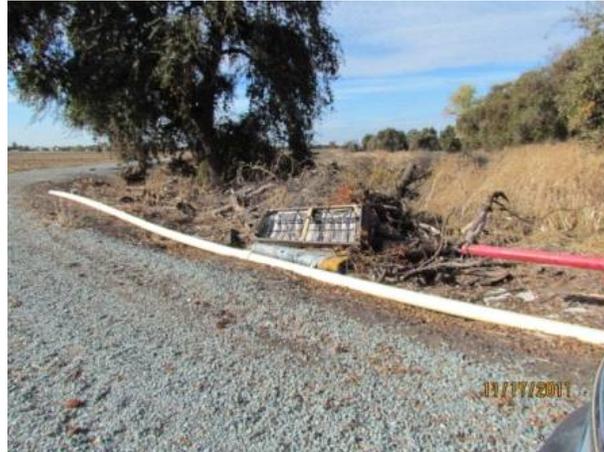
Levee Mile Report Line	10
Start Levee Mile	1.28
End Levee Mile	1.28
Location	Water Side
Category	Earthen Levee
Item	Encroachments
Debris was found on the waterside of the levee looking downstream.	
pkazi_f_20120913_006.jpg

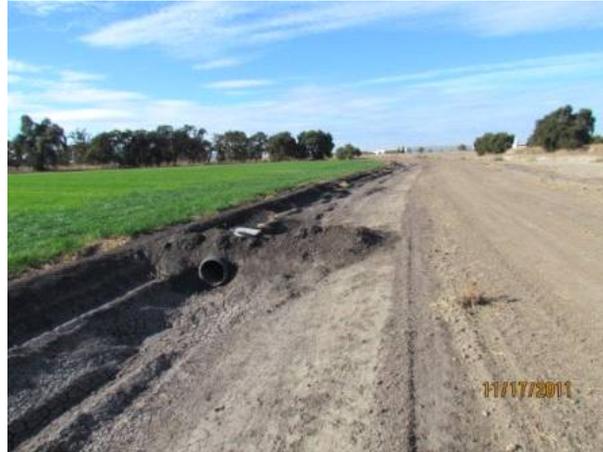
Levee Mile Report Line	13
Start Levee Mile	1.52
End Levee Mile	1.58
Location	Land Side
Category	Earthen Levee
Item	Encroachments
An agricultural ditch was found on the landside of the levee looking downstream.	
pkazi_f_20120913_002.jpg

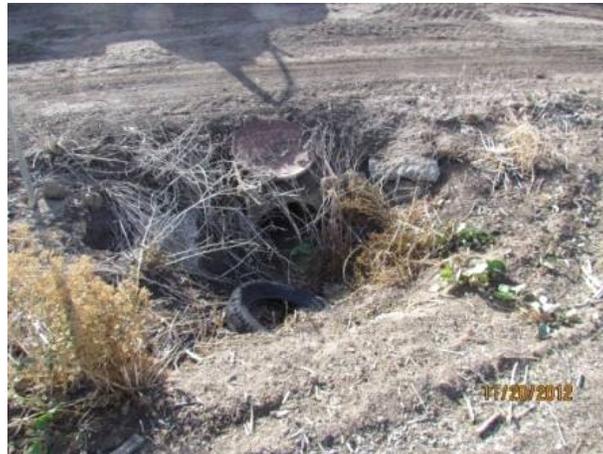
Levee Mile Report Line	16
Start Levee Mile	2.81
End Levee Mile	2.81
Location	Water Side
Category	Interior Drainage & Piping Systems
Item	Flap Gates
The flap gate appeared to be damaged on the waterside of the levee looking downstream.	
pkazi_f_20121126_153.jpg

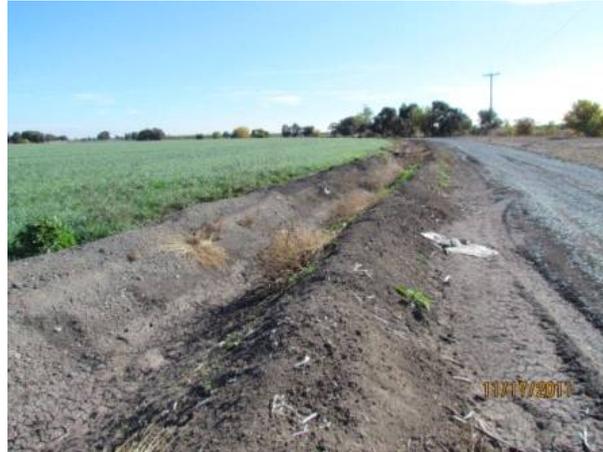
Levee Mile Report Line	1
Start Levee Mile	1.51
End Levee Mile	1.84
Location	Land Side
Category	Earthen Levee
Item	Encroachments
An agriculture ditch was found on the landside of the levee looking upstream.	
pkazi_f_20120913_019.jpg

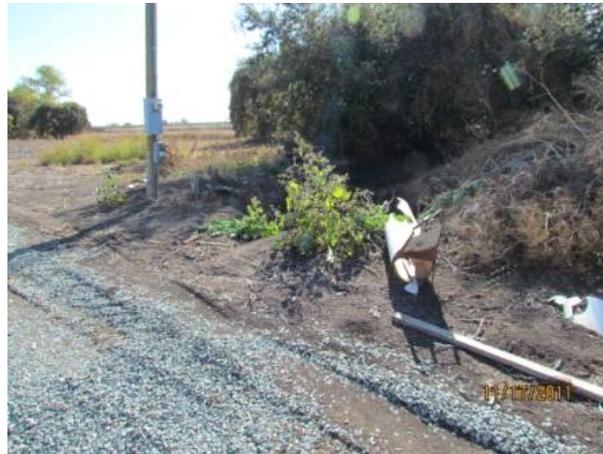
Levee Mile Report Line	2
Start Levee Mile	1.74
End Levee Mile	1.74
Location	Water Side
Category	Earthen Levee
Item	Encroachments
Debris was found on the waterside of the levee looking upstream.	
pkazi_f_20120913_020.jpg

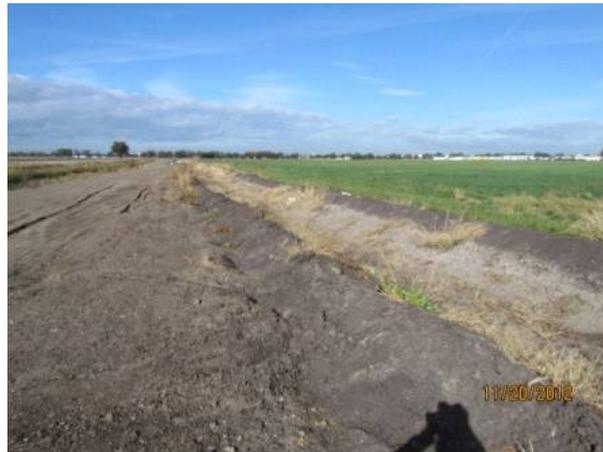
Levee Mile Report Line	3
Start Levee Mile	1.93
End Levee Mile	2.65
Location	Land Side
Category	Earthen Levee
Item	Encroachments
A ditch was found on the landside of the levee looking downstream.	
pkazi_f_20121126_154.jpg

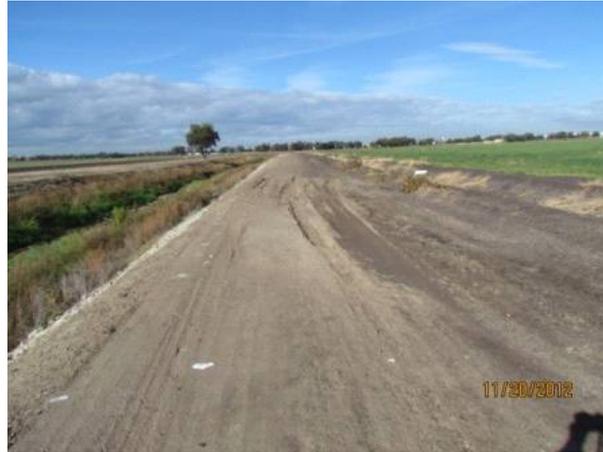
Levee Mile Report Line	4
Start Levee Mile	2.00
End Levee Mile	2.00
Location	Crown
Category	Earthen Levee
Item	Crown Surface / Depressions / Rutting
Crown depression was found on the access road looking downstream.	
pkazi_f_20121126_155.jpg

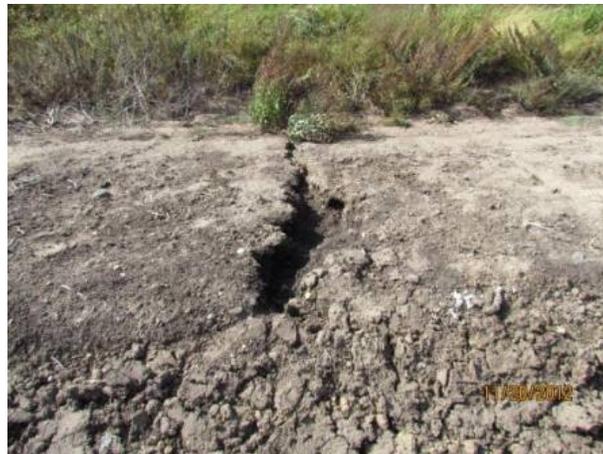
Levee Mile Report Line	6
Start Levee Mile	2.17
End Levee Mile	2.17
Location	Water Side
Category	Earthen Levee
Item	Erosion / Bank Caving
Erosion was found on the waterside slope of the levee looking downstream.	
pkazi_f_20121126_156.jpg

DWR ID: DWR_NA0017_02_s_2012_11										
6	2.17	2.17	Earthen Levee	Erosion / Bank Caving	WS	M Ma	E2 : Schedule repair of erosion site prior to the next inspection.	37.883925 ° -121.253006 °	37.883925 ° -121.253006 °	2 Y
DWR ID: DWR_NA0017_02_f_2012_2										
7	2.26	2.26	Earthen Levee	Erosion / Bank Caving	WS	A Ma	E2 : Schedule repair of erosion site prior to the next inspection. Inspector Comments: LMA repaired the erosion site.	37.884956 ° -121.253911 °	37.884956 ° -121.253911 °	3 Y
DWR ID: DWR_NA0017_02_s_2012_3										
8	2.54	2.54	Earthen Levee	Erosion / Bank Caving	WS	C Ma	E2 : Schedule repair of erosion site prior to the next inspection.	37.888239 ° -121.256586 °	37.888239 ° -121.256586 °	15 Y
DWR ID: DWR_NA0017_02_s_2012_15										
9	2.55	2.55	Earthen Levee	Erosion / Bank Caving	WS	A Ma	E2 : Schedule repair of erosion site prior to the next inspection. Inspector Comments: LMA has fixed the issue.	37.888380 ° -121.256801 °	37.888380 ° -121.256801 °	5 Y

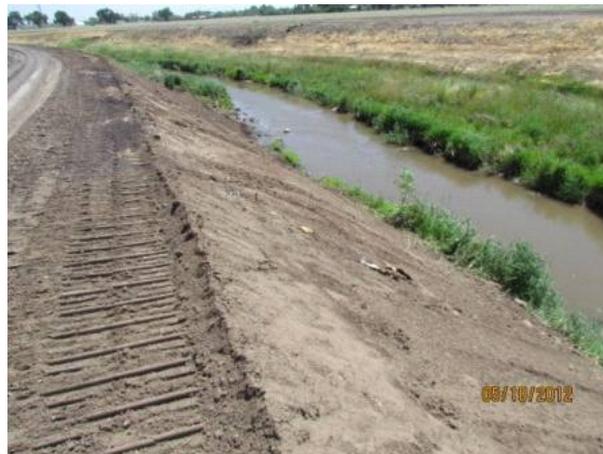
Levee Mile Report Line	7
Start Levee Mile	2.26
End Levee Mile	2.26
Location	Water Side
Category	Earthen Levee
Item	Erosion / Bank Caving
Erosion was repaired by the LMA on the waterside slope of the levee looking upstream.	
pkazi_f_20120913_012.jpg

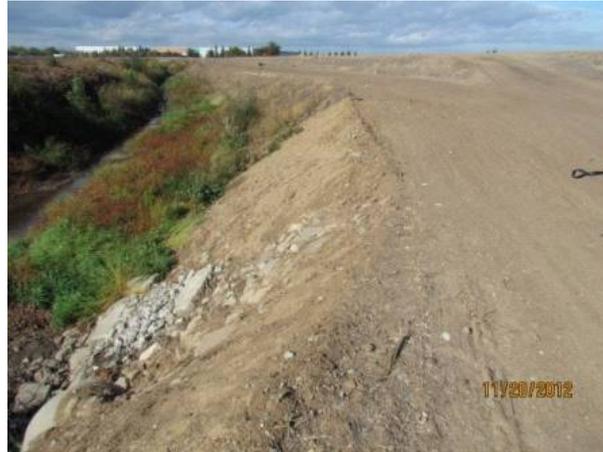
pkazi_f_20121126_157.jpg

Existing erosion was repaired by the LMA on the waterside slope of the levee looking downstream.

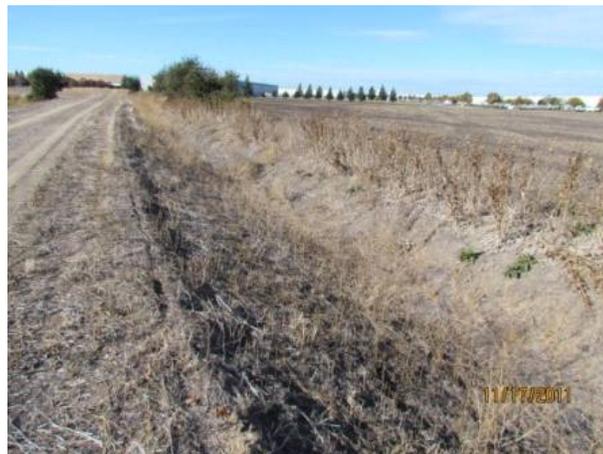
pkazi_f_20120913_017.jpg

A ditch was found on the landside of the levee looking downstream.

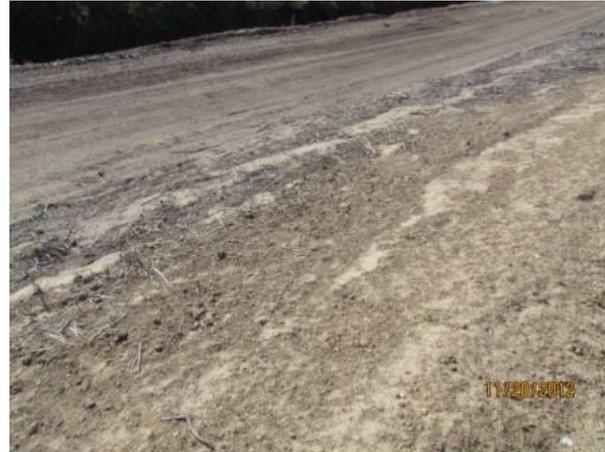
Levee Mile Report Line	17
Start Levee Mile	2.80
End Levee Mile	2.80
Location	Water Side
Category	Earthen Levee
Item	Animal Control
Animal hole was repaired by the LMA on the waterside slope of the levee looking downstream.	
pkazi_f_20121126_159.jpg

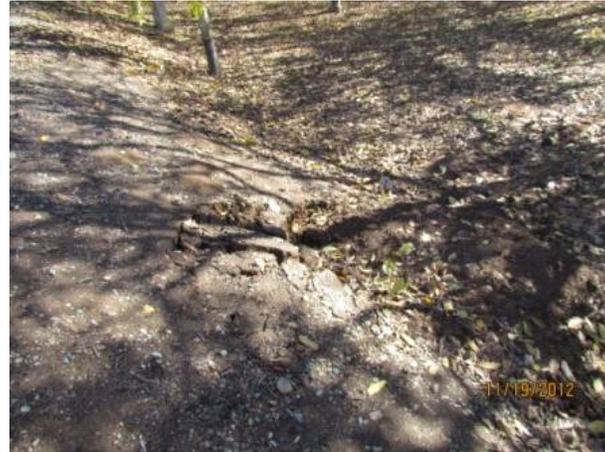
pkazi_f_20121121_135.jpg

Slope instability was found on the landside toe of the levee looking upstream.

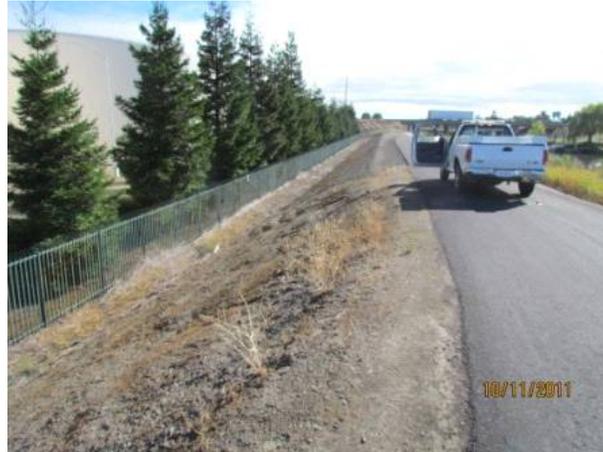
Levee Mile Report Line	1
Start Levee Mile	0.39
End Levee Mile	0.50
Location	Land Side
Category	Earthen Levee
Item	Encroachments
View of the fence along landside toe of the levee looking upstream.	
pkazi_f_20120913_024.jpg

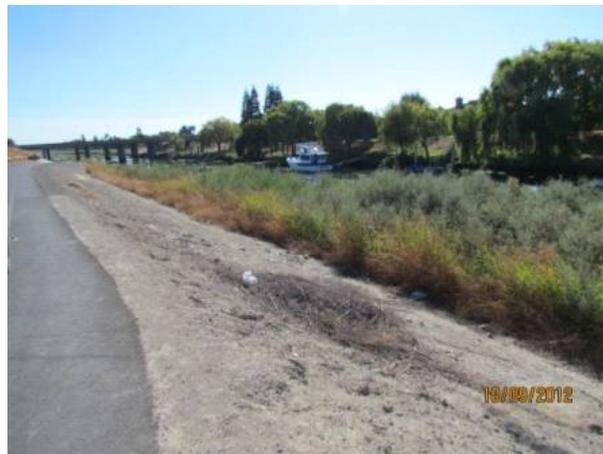
Levee Mile Report Line	2
Start Levee Mile	0.40
End Levee Mile	0.40
Location	Water Side
Category	Earthen Levee
Item	Vegetation
View of the vegetation on the waterside toe of the levee looking upstream.	
pkazi_f_20121014_923.jpg

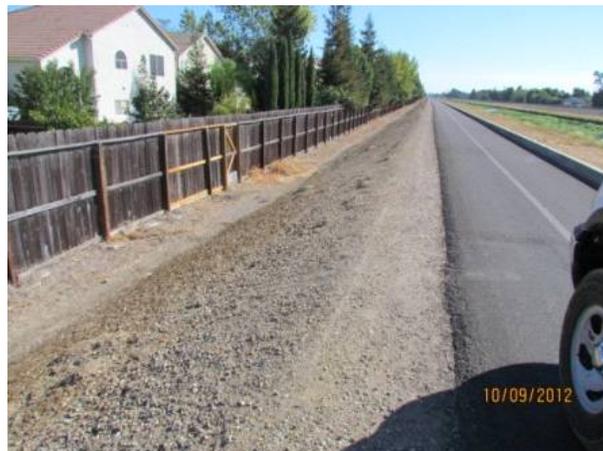
Levee Mile Report Line	6
Start Levee Mile	0.92
End Levee Mile	0.92
Location	Land Side
Category	Earthen Levee
Item	Slope Stability
Slope instability issue was fixed by the LMA on the landside slope of the levee looking upstream.	
pkazi_f_20121014_924.jpg

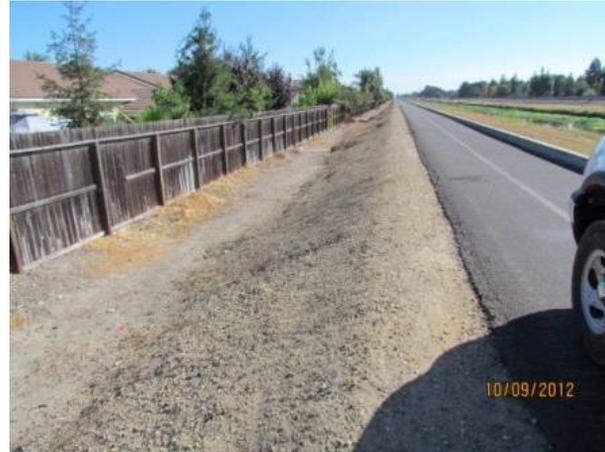
Levee Mile Report Line	8
Start Levee Mile	1.11
End Levee Mile	1.11
Location	Land Side
Category	Earthen Levee
Item	Slope Stability
Slope instability issue was fixed by the LMA on the landside slope of the levee looking upstream.	
pkazi_f_20121014_925.jpg

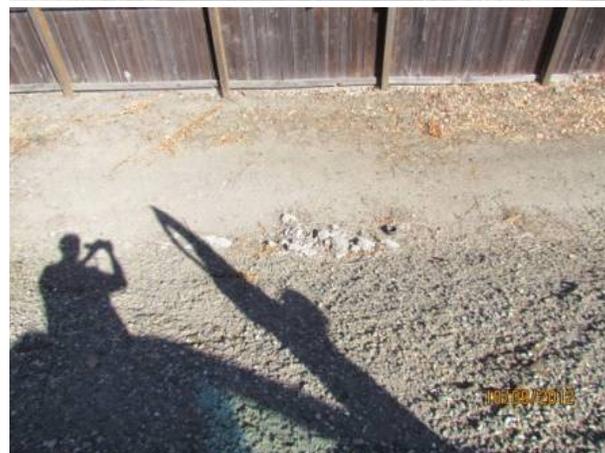
Levee Mile Report Line	11
Start Levee Mile	1.21
End Levee Mile	1.21
Location	Land Side
Category	Earthen Levee
Item	Encroachments
Concrete debris was found on the landside toe of the levee looking upstream.	
pkazi_f_20121014_927.jpg

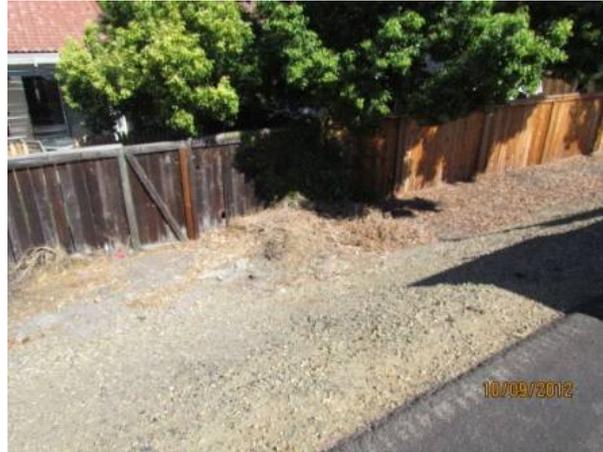
Levee Mile Report Line	16
Start Levee Mile	1.82
End Levee Mile	1.82
Location	Land Side
Category	Earthen Levee
Item	Encroachments
Debris was found on the landside toe of the levee looking upstream.	
pkazi_f_20121014_928.jpg

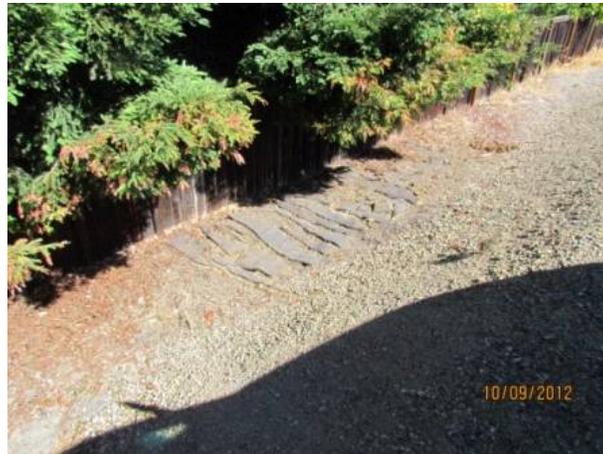
Levee Mile Report Line	17
Start Levee Mile	1.86
End Levee Mile	1.86
Location	Land Side
Category	Earthen Levee
Item	Encroachments
Debris was found on the landside toe of the levee looking upstream.	
pkazi_f_20121014_929.jpg

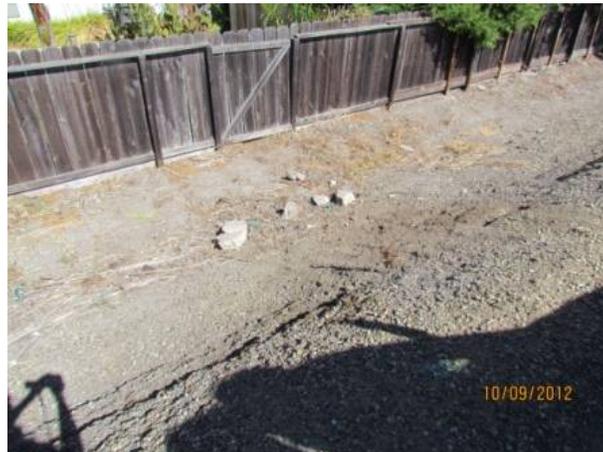
Levee Mile Report Line	21
Start Levee Mile	2.06
End Levee Mile	2.06
Location	Land Side
Category	Earthen Levee
Item	Encroachments
Concrete debris was found on the landside toe of the levee looking upstream.	
pkazi_f_20121014_930.jpg

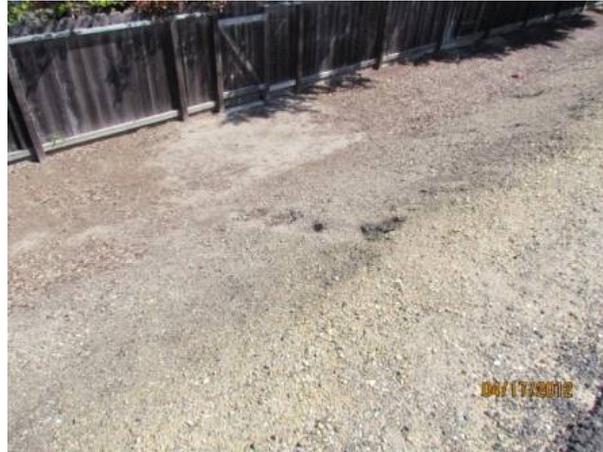
Levee Mile Report Line	22
Start Levee Mile	2.12
End Levee Mile	2.12
Location	Land Side
Category	Earthen Levee
Item	Encroachments
Steps were dug on the landside slope of the levee looking upstream.	
pkazi_f_20120913_033.jpg

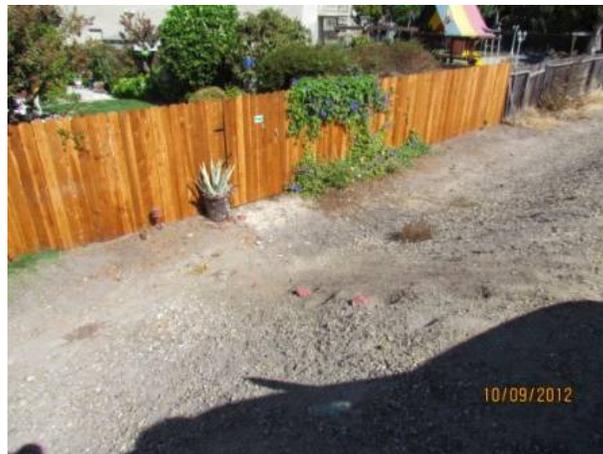
Levee Mile Report Line	24
Start Levee Mile	2.28
End Levee Mile	2.28
Location	Land Side
Category	Earthen Levee
Item	Encroachments
Stairs were carved on the landside slope of the levee looking upstream.	
pkazi_f_20121014_931.jpg

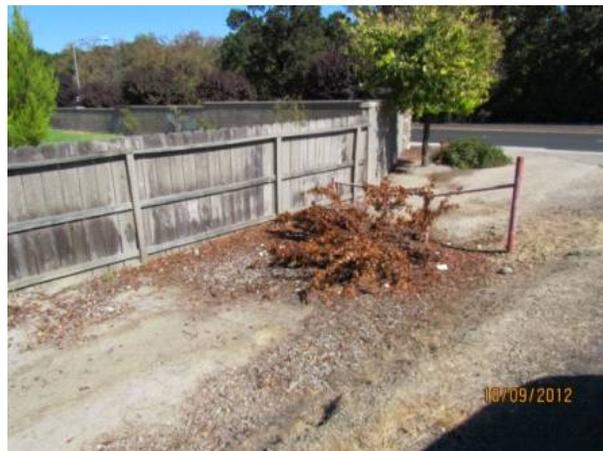
Levee Mile Report Line	26
Start Levee Mile	2.52
End Levee Mile	2.52
Location	Land Side
Category	Earthen Levee
Item	Encroachments
Prunings was found on the landside slope of the levee looking upstream.	
pkazi_f_20121014_932.jpg

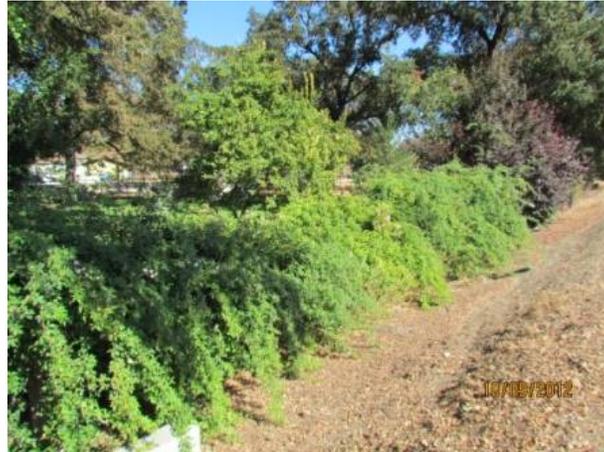
Levee Mile Report Line	27
Start Levee Mile	2.57
End Levee Mile	2.57
Location	Land Side
Category	Earthen Levee
Item	Vegetation
Landscaping was found on the landside of the levee looking upstream.	
pkazi_f_20121014_933.jpg

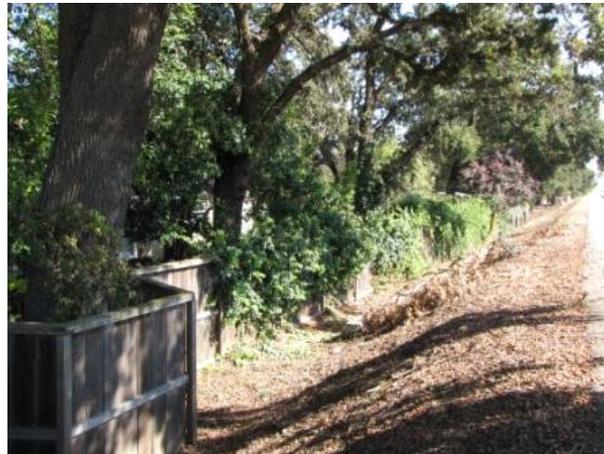
Levee Mile Report Line	28
Start Levee Mile	2.57
End Levee Mile	2.65
Location	Land Side
Category	Earthen Levee
Item	Encroachments
View of a wood fence adjacent to the landward toe looking upstream.	
pkazi_f_20120913_102.jpg

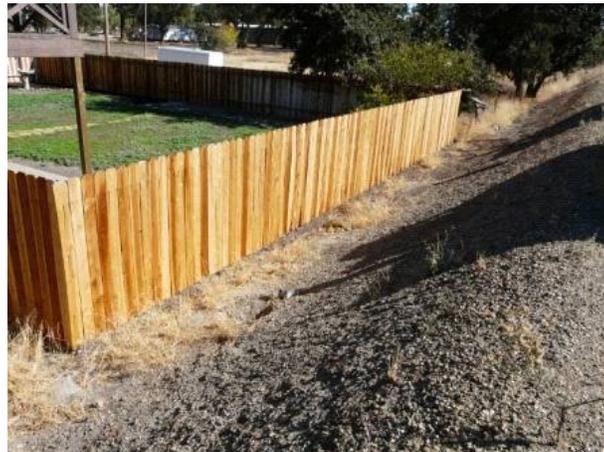
Levee Mile Report Line	29
Start Levee Mile	2.66
End Levee Mile	2.67
Location	Land Side
Category	Earthen Levee
Item	Encroachments
Newer fence built within landside toe of levee at from LM 2.66 to LM 2.67.	
pkazi_f_20120913_045.JPG

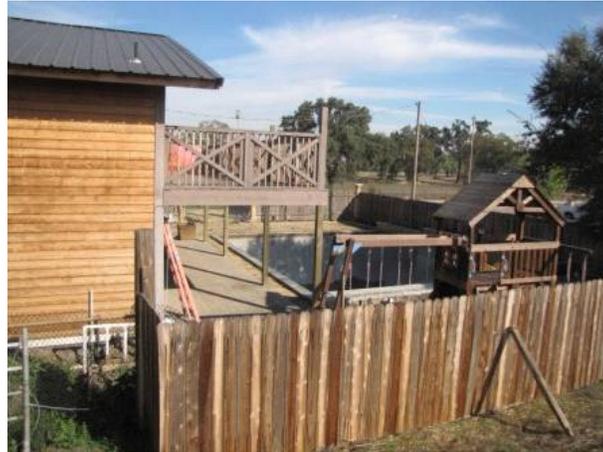
Levee Mile Report Line	30
Start Levee Mile	2.67
End Levee Mile	2.67
Location	Land Side
Category	Earthen Levee
Item	Encroachments
View of a recently constructed pool looking landward.	
pkazi_f_20120913_060.jpg

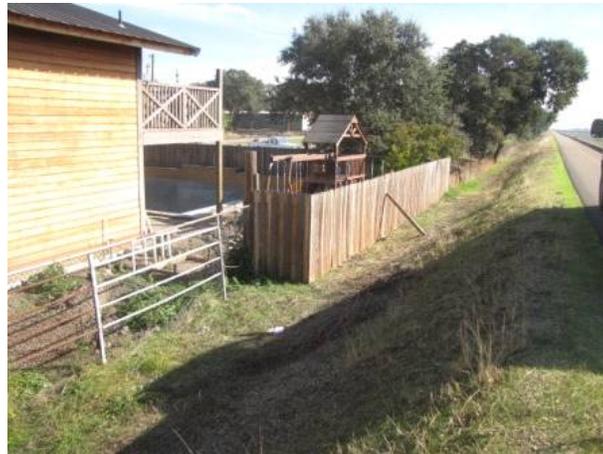
Levee Mile Report Line	30
Start Levee Mile	2.67
End Levee Mile	2.67
Location	Land Side
Category	Earthen Levee
Item	Encroachments
View of a recently constructed pool looking upstream.	
pkazi_f_20120913_061.jpg

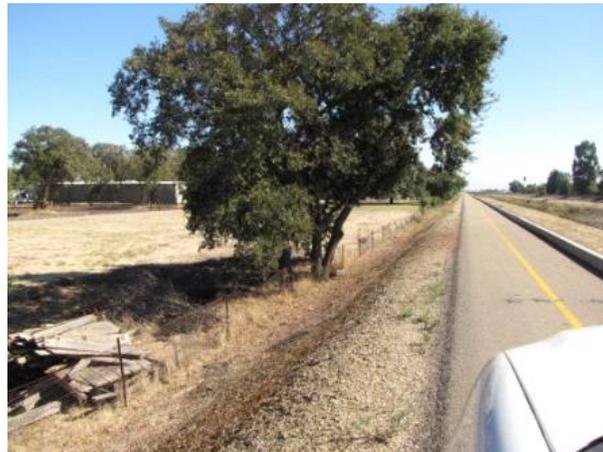
Levee Mile Report Line	31
Start Levee Mile	2.68
End Levee Mile	3.04
Location	Land Side
Category	Earthen Levee
Item	Encroachments
View of a metal fence adjacent to the landward toe looking upstream.	
pkazi_f_20120913_103.jpg

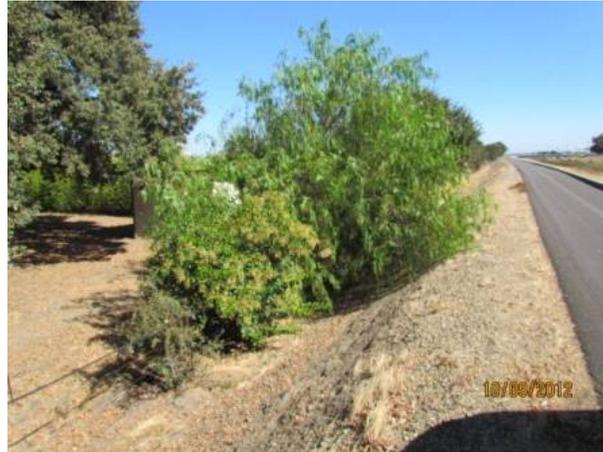
Levee Mile Report Line	32
Start Levee Mile	2.82
End Levee Mile	2.82
Location	Land Side
Category	Earthen Levee
Item	Trim / Thin Trees
Overgrown tree was obstructing the view of the landside levee slope looking upstream.	
pkazi_f_20121014_934.jpg

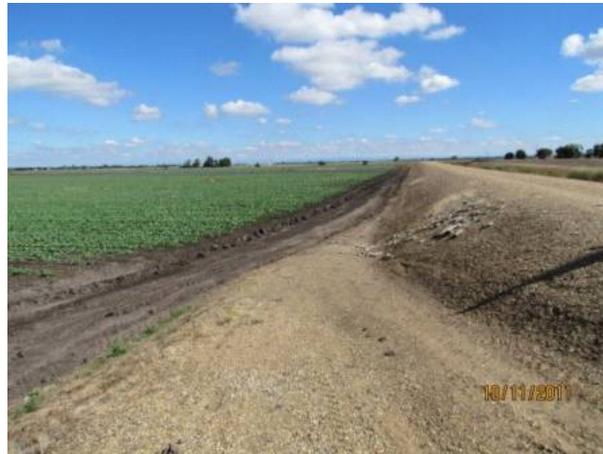
Levee Mile Report Line	36
Start Levee Mile	3.16
End Levee Mile	3.35
Location	Land Side
Category	Earthen Levee
Item	Encroachments
Farmer discing the toe of the landside of the levee looking upstream.	
pkazi_f_20120913_079.jpg

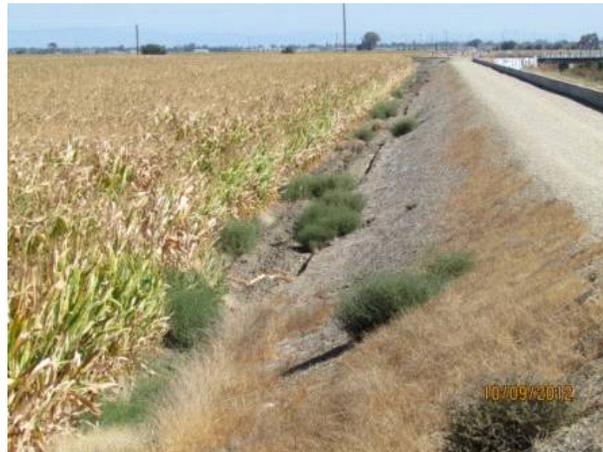
Levee Mile Report Line	36
Start Levee Mile	3.16
End Levee Mile	3.35
Location	Land Side
Category	Earthen Levee
Item	Encroachments
Updated picture of the toe cutting on the landside toe of the levee looking upstream.	
pkazi_f_20121014_935.jpg

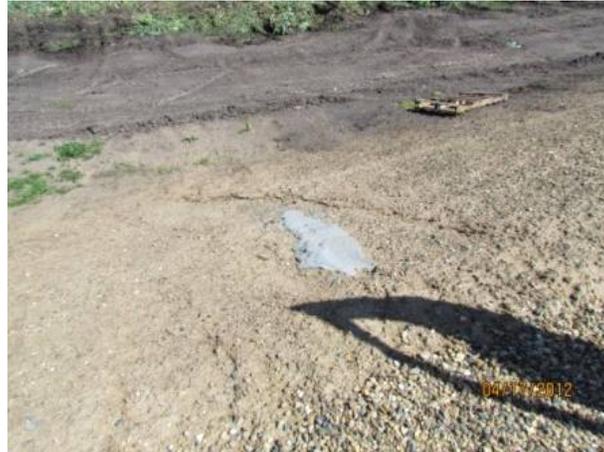
Levee Mile Report Line	40
Start Levee Mile	3.92
End Levee Mile	3.92
Location	Land Side
Category	Earthen Levee
Item	Animal Control
<p>Animal holes were grouted by the LMA on the landside slope of the levee looking towards the toe.</p>	
<p>pkazi_f_20120913_025.jpg</p>

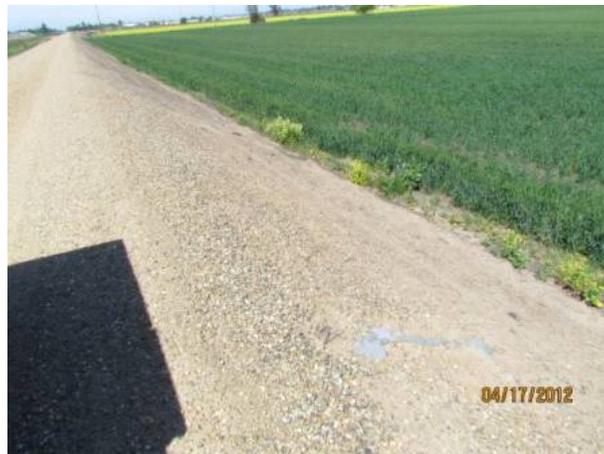
Levee Mile Report Line	41
Start Levee Mile	3.93
End Levee Mile	3.93
Location	Land Side
Category	Earthen Levee
Item	Slope Stability
<p>Slope instability was fixed by the LMA on the landside of the levee looking downstream.</p>	
<p>pkazi_f_20120913_035.jpg</p>

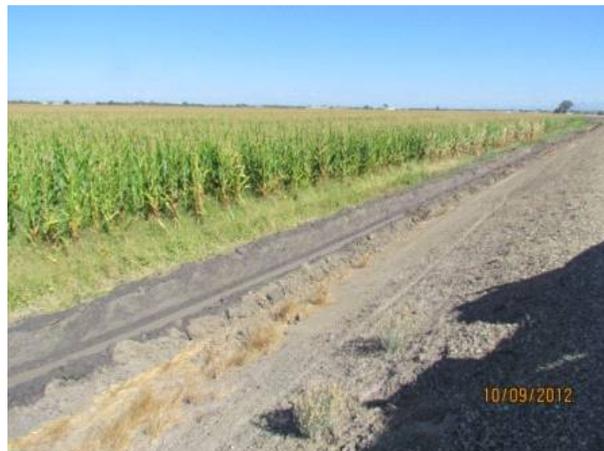
Levee Mile Report Line	42
Start Levee Mile	4.10
End Levee Mile	4.35
Location	Land Side
Category	Earthen Levee
Item	Encroachments
<p>A ditch was found on the landside toe of the levee looking upstream.</p>	
<p>pkazi_f_20121014_936.jpg</p>

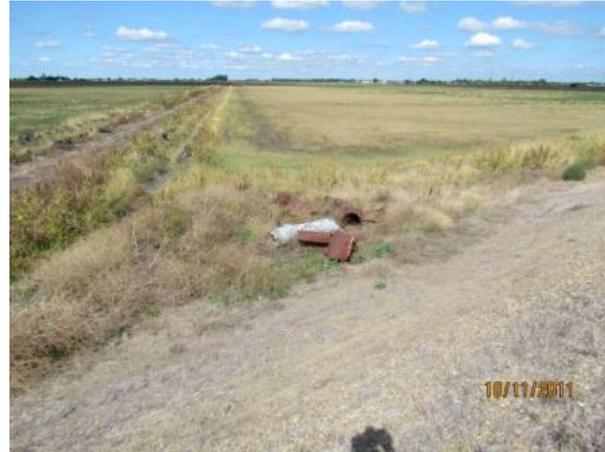
Levee Mile Report Line	43
Start Levee Mile	4.37
End Levee Mile	4.37
Location	Land Side
Category	Earthen Levee
Item	Encroachments
Metal pipes were found on the landside of the levee looking upstream.	
pkazi_f_20120913_080.jpg

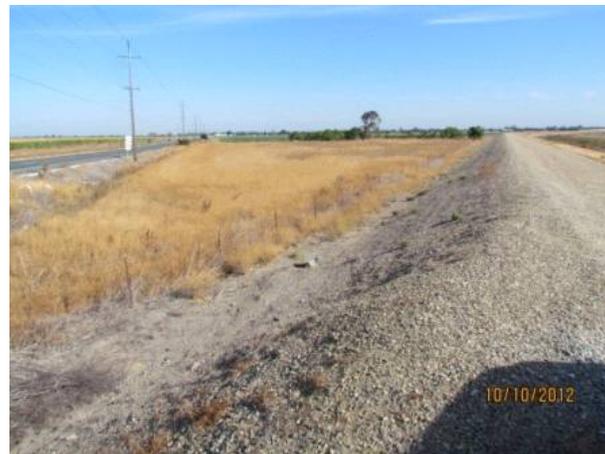
Levee Mile Report Line	44
Start Levee Mile	4.66
End Levee Mile	5.63
Location	Land Side
Category	Earthen Levee
Item	Encroachments
View of the fence on the landside toe of the levee looking upstream.	
pkazi_f_20121014_937.jpg

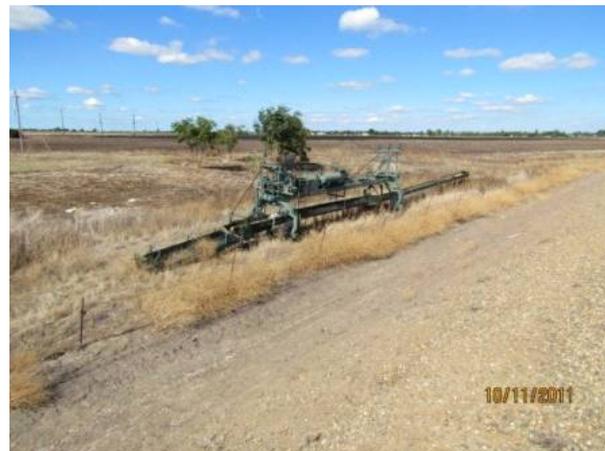
Levee Mile Report Line	45
Start Levee Mile	4.83
End Levee Mile	4.83
Location	Land Side
Category	Earthen Levee
Item	Encroachments
Abandoned equipment was found on the landside of the levee looking upstream.	
pkazi_f_20120913_038.jpg

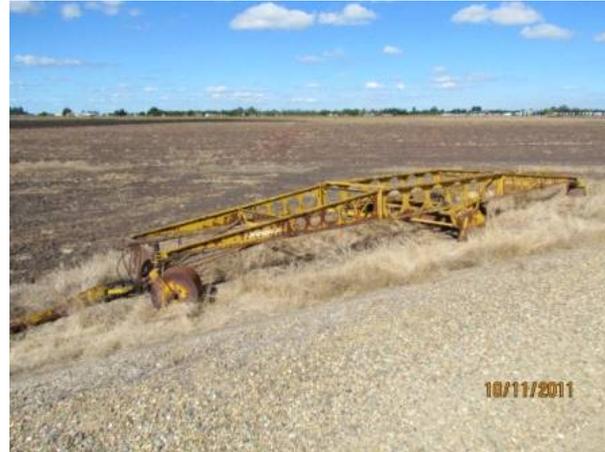
Levee Mile Report Line	46
Start Levee Mile	5.10
End Levee Mile	5.10
Location	Land Side
Category	Earthen Levee
Item	Encroachments
Abandoned equipment was found on the landside of the levee looking upstream.	
pkazi_f_20120913_081.jpg

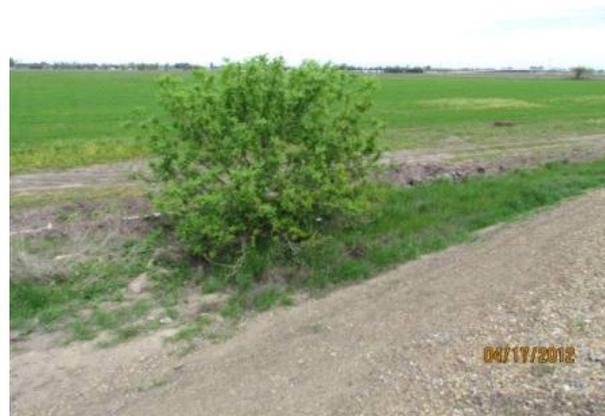
Levee Mile Report Line	47
Start Levee Mile	5.12
End Levee Mile	5.12
Location	Land Side
Category	Earthen Levee
Item	Trim / Thin Trees
Tree needs to be trimmed for flood fighting access. The picture was taken from the crown looking towards the toe.	
pkazi_f_20120913_036.jpg

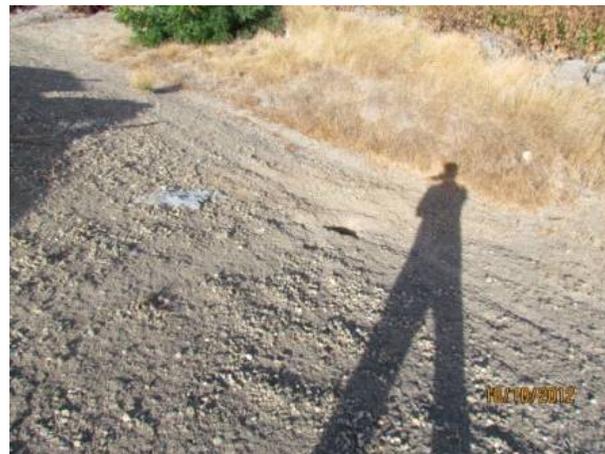
Levee Mile Report Line	48
Start Levee Mile	5.12
End Levee Mile	5.12
Location	Land Side
Category	Earthen Levee
Item	Animal Control
An animal hole was found on the landside of the levee looking downstream.	
pkazi_f_20121014_938.jpg

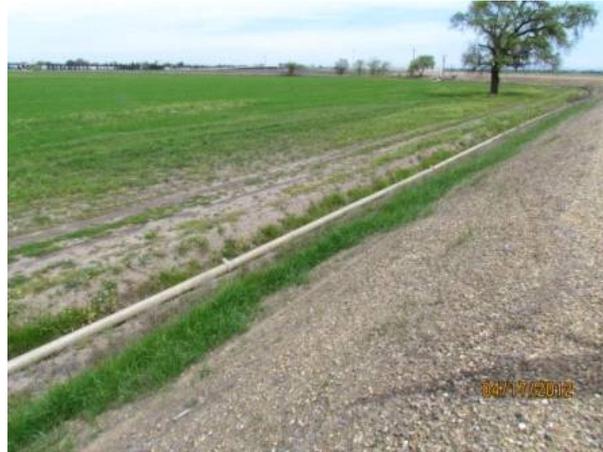
Levee Mile Report Line	49
Start Levee Mile	5.13
End Levee Mile	5.27
Location	Land Side
Category	Earthen Levee
Item	Encroachments
An agriculture ditch was found on the landside toe of the levee looking upstream.	
pkazi_f_20120913_064.jpg

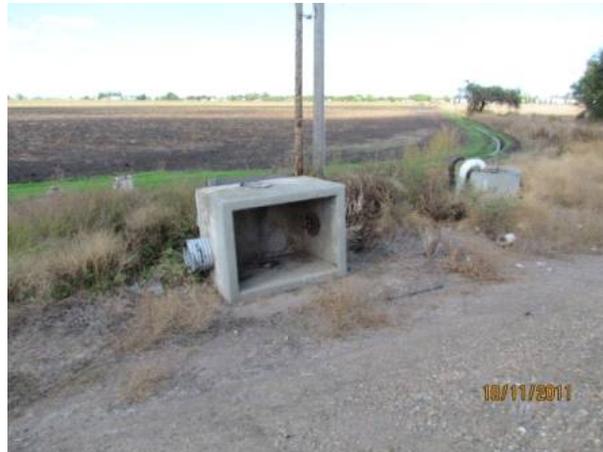
Levee Mile Report Line	50
Start Levee Mile	5.28
End Levee Mile	5.28
Location	Land Side
Category	Earthen Levee
Item	Encroachments
Abandoned culvert joint was found on the landside toe of the levee looking upstream.	
pkazi_f_20120913_082.jpg

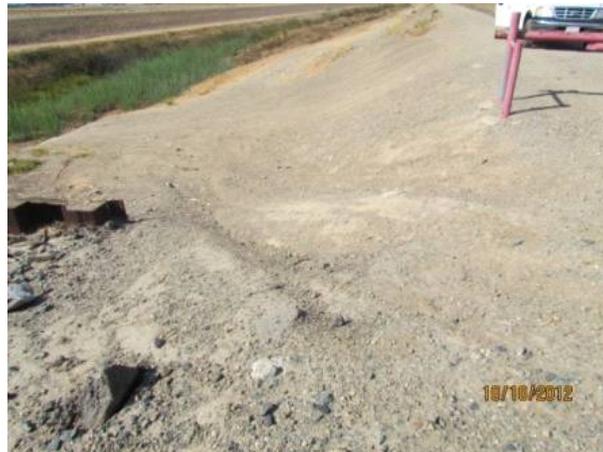
Levee Mile Report Line	51
Start Levee Mile	5.85
End Levee Mile	5.85
Location	Water Side
Category	Earthen Levee
Item	Slope Stability
Slope instability was found on the landside of the levee looking upstream.	
pkazi_f_20121014_939.jpg

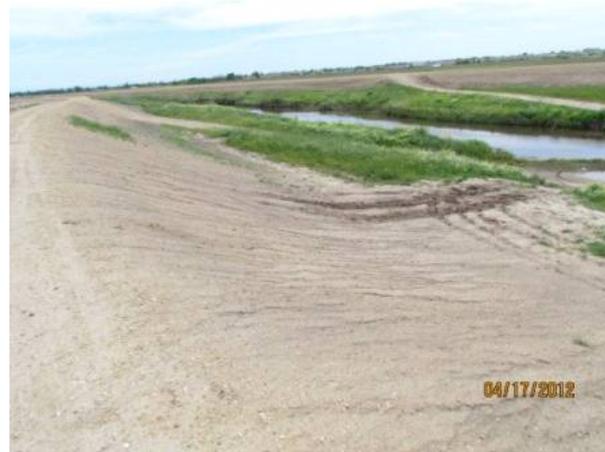
Levee Mile Report Line	52
Start Levee Mile	5.89
End Levee Mile	5.89
Location	Water Side
Category	Earthen Levee
Item	Slope Stability
Slope instability caused by vehicular traffic was found on the waterside slope of the levee looking upstream.	
pkazi_f_20120913_037.jpg

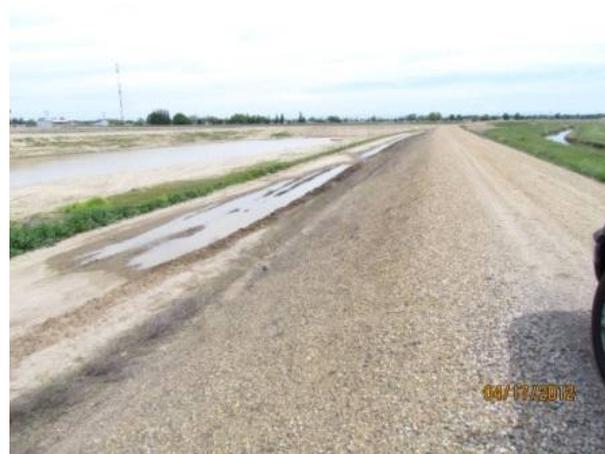
Levee Mile Report Line	53
Start Levee Mile	6.06
End Levee Mile	6.16
Location	Land Side
Category	Earthen Levee
Item	Slope Stability
Ponded water was found on the landside toe of the levee looking upstream.	
pkazi_f_20120913_039.jpg

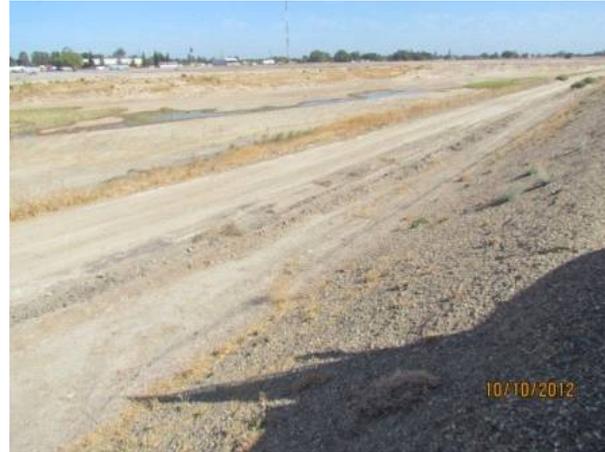
pkazi_f_20121014_940.jpg

Updated picture of the ditch on the landside toe of the levee looking upstream.

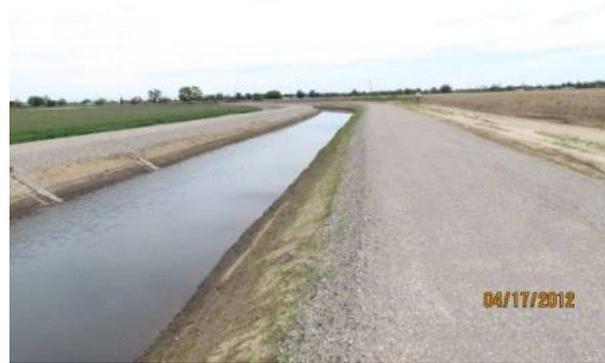
Levee Mile Report Line	54
Start Levee Mile	6.24
End Levee Mile	6.24
Location	Land Side
Category	Earthen Levee
Item	Encroachments

A 20 feet wide channel was dug on the landside of the levee looking upstream.

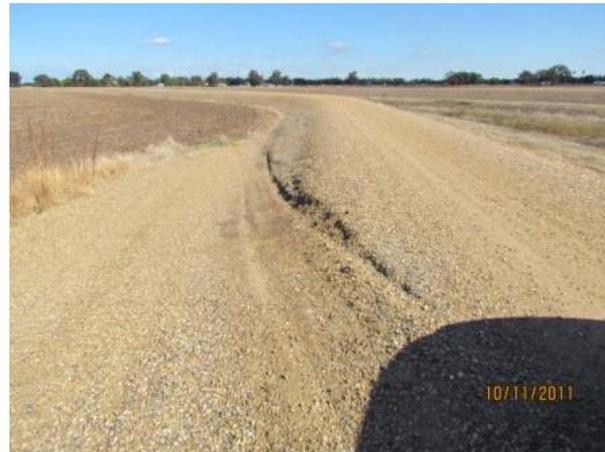
Levee Mile Report Line	56
Start Levee Mile	6.52
End Levee Mile	6.52
Location	Land Side
Category	Earthen Levee
Item	Slope Stability

Slope instability was caused by vehicular traffic on the landside of the levee looking upstream.

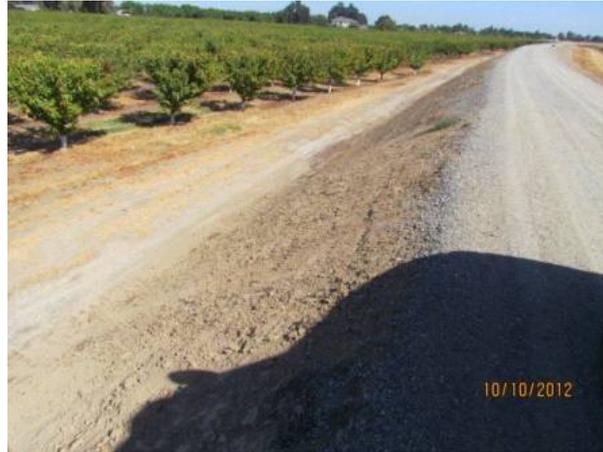
Levee Mile Report Line	58
Start Levee Mile	7.25
End Levee Mile	7.25
Location	Land Side
Category	Earthen Levee
Item	Slope Stability
Slope instability issue was fixed by the LMA on the landside of the levee looking upstream.	
pkazi_f_20121014_941.jpg

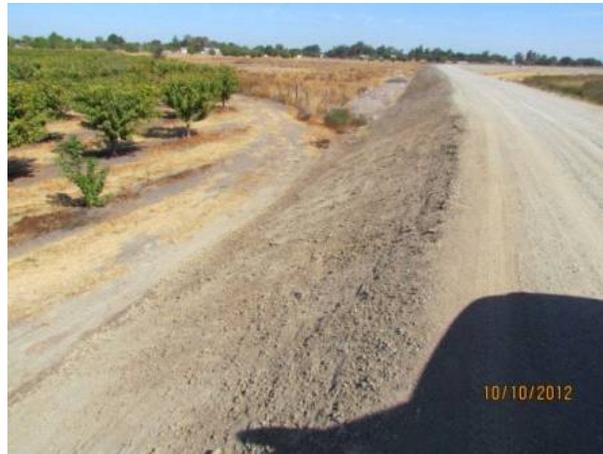
Levee Mile Report Line	60
Start Levee Mile	7.50
End Levee Mile	7.50
Location	Land Side
Category	Earthen Levee
Item	Slope Stability
Slope instability issue was fixed by the LMA on the landside of the levee looking upstream.	
pkazi_f_20121014_942.jpg

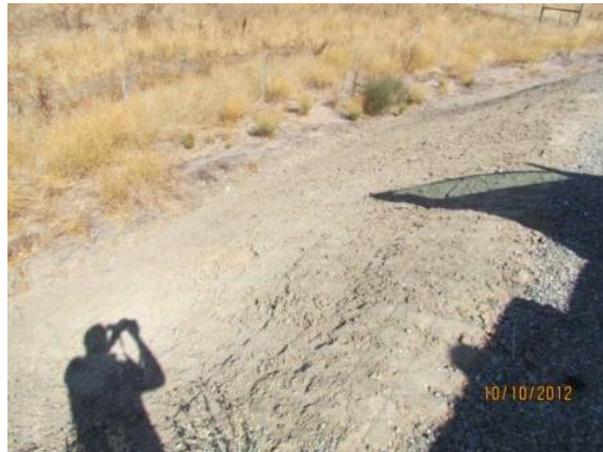
Levee Mile Report Line	61
Start Levee Mile	7.56
End Levee Mile	7.56
Location	Land Side
Category	Earthen Levee
Item	Animal Control
Animal hole was fixed by the LMA on the landside of the levee looking upstream.	
pkazi_f_20121014_943.jpg

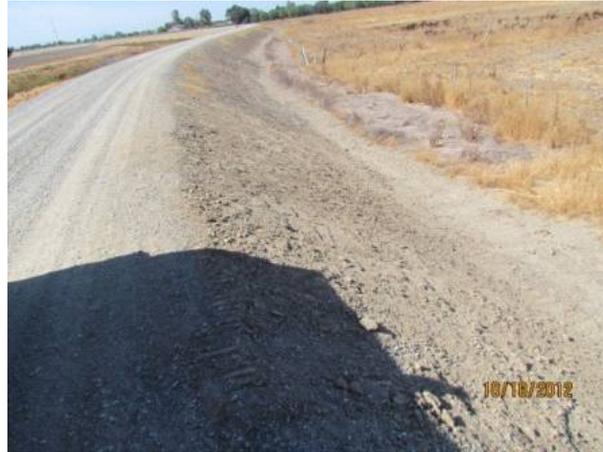
Levee Mile Report Line	65
Start Levee Mile	7.74
End Levee Mile	7.74
Location	Land Side
Category	Earthen Levee
Item	Slope Stability
Slope instability issue was fixed by the LMA on the landside of the levee looking downstream.	
pkazi_f_20121014_944.jpg

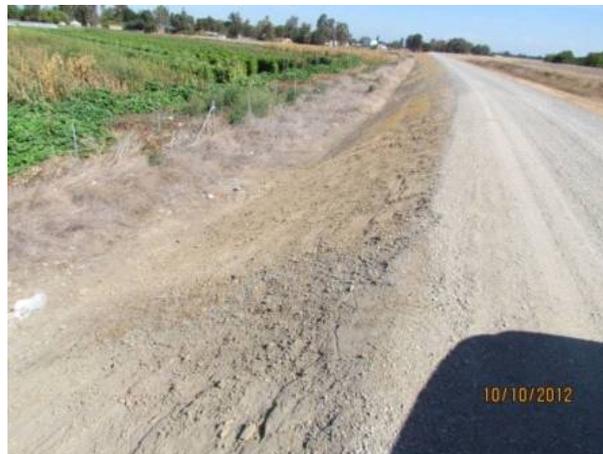
Levee Mile Report Line	67
Start Levee Mile	7.78
End Levee Mile	7.78
Location	Land Side
Category	Earthen Levee
Item	Slope Stability
Slope instability issue was fixed by the LMA on the landside of the levee looking upstream.	
pkazi_f_20121014_945.jpg

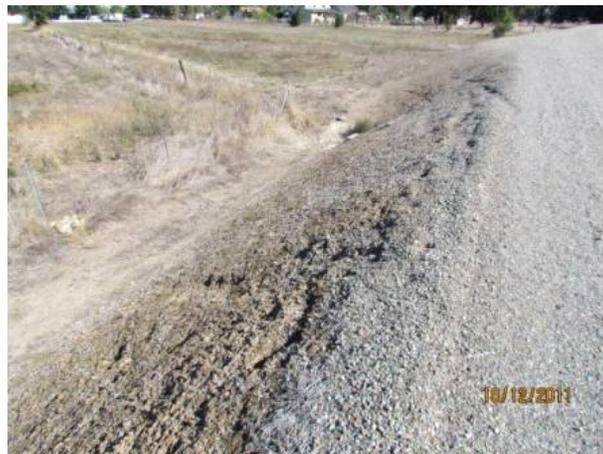
Levee Mile Report Line	68
Start Levee Mile	7.98
End Levee Mile	7.98
Location	Land Side
Category	Earthen Levee
Item	Slope Stability
Slope instability was found on the landside of the levee looking upstream.	
pkazi_f_20120913_087.jpg

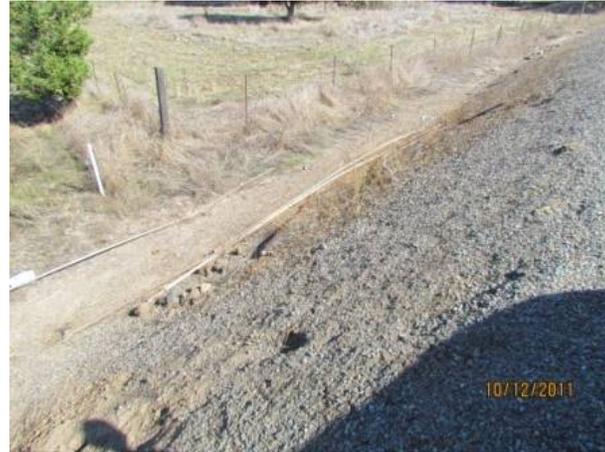
pkazi_f_20120913_088.jpg

Abandoned irrigation pipe was found on the landside of the levee looking upstream.

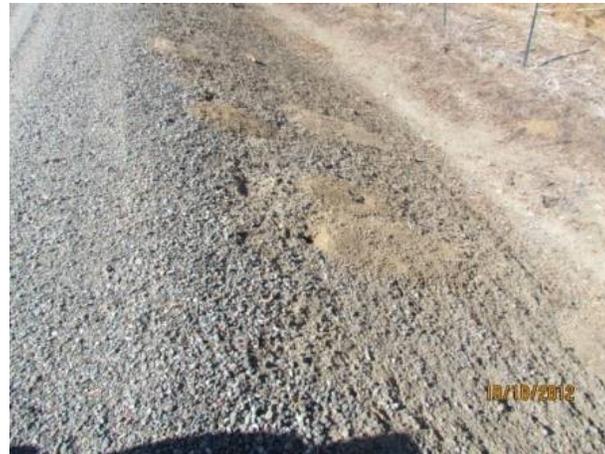
Levee Mile Report Line	71
Start Levee Mile	8.10
End Levee Mile	8.10
Location	Land Side
Category	Earthen Levee
Item	Animal Control

Animal holes were found on the landside of the levee looking downstream.

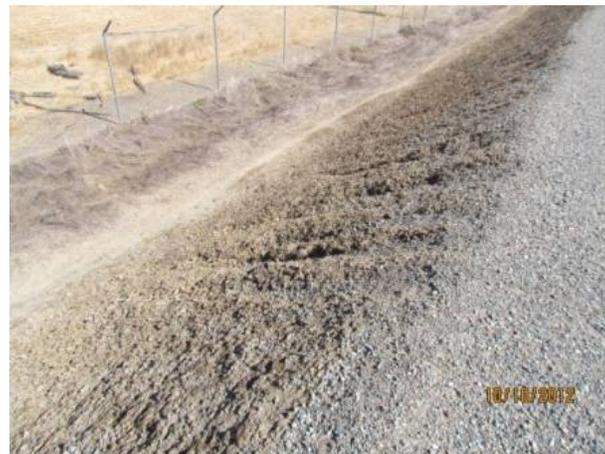
Levee Mile Report Line	73
Start Levee Mile	8.17
End Levee Mile	8.17
Location	Land Side
Category	Earthen Levee
Item	Slope Stability

Slope instability was found on the landside of the levee looking upstream.
